AIAA Space 2011 Conference

NASA/MOD Operations Impacts from Shuttle Program

Authors: Michael Fitzpatrick, Gregory Mattes, Michael Grabois, Holly Griffith

## II. STS-27 Post-Landing Cooling Anomaly

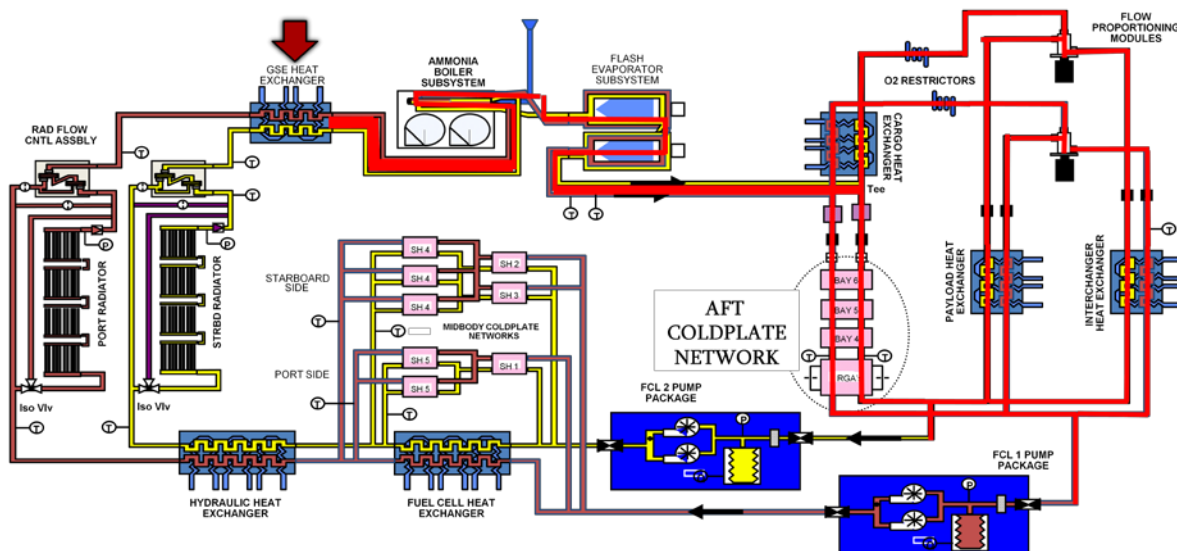
Figure 1. Space Shuttle Freon Coolant Loop schematic.

As seen in Fig. 1, the Space Shuttle has two Freon Loops, both of which are typically running at all times. Post-landing, the ground Cooling Cart is connected to the Orbiter at the GSE Heat Exchanger, represented by the red arrow at top left. The Freon continues clockwise in this schematic, reaching the Ammonia Boiler and the FES before splitting into legs cooling the aft coldplates, the payloads, and the water coolant loops. A Flow Proportioning Valve can set the flows to be a ratio of either 90% at the Water/Freon Interchanger and 10% at the Payload Heat Exchanger, or 57% to 43%. From these legs, the Freon goes through a pump package, heat exchangers for the Fuel Cells and midbody coldplates, and finally the radiators before reaching the GSE Heat Exchanger again. The Water/Freon Interchanger at far right is where all of the Orbiter's coolant loops intersect, and if the Freon temperature is cold enough it could freeze the water, rupture the interchanger, and cause the complete loss of cooling to the Orbiter.

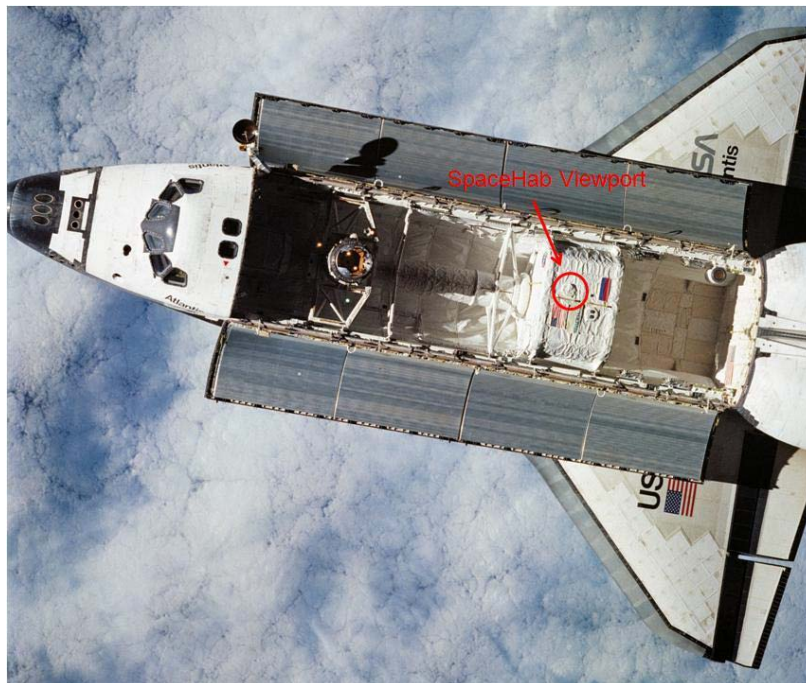
**Figure 5: View of Shuttle showing location of SpaceHab viewport.**

This mission carried a single module SpaceHab in the payload bay. The SpaceHab's main purpose was to provide increased habitable volume for storage and science payloads, connected to the crew cabin via the external airlock. On the top of the SpaceHab was a viewport window that fortuitously was directly underneath the 9-12 Latch Gang. See Fig. 5 for a photo of the SpaceHab within the Shuttle's payload bay; each gang of latches (1-4, 5-8, 9-12, and 13-16) occupies one of the four radiator panels that line the payload bay doors from forward to aft.

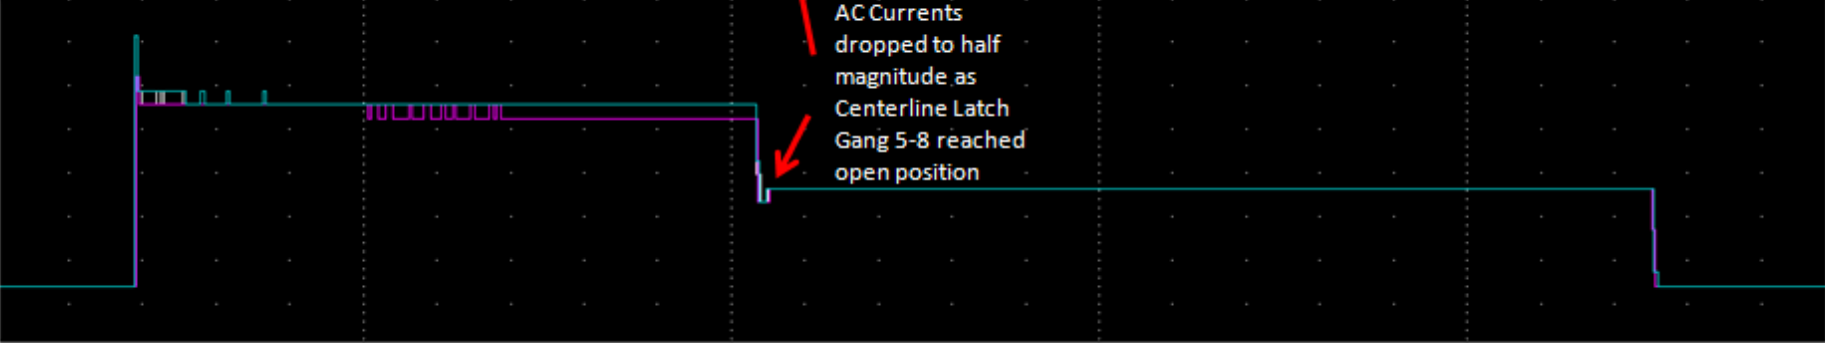
PLBD Centerline Latch Microswitch Indications

- PLBD centerline latch gang 9-12
  - Came off two closed microswitches
  - Did not receive two open microswitches
  - Alternating current traces were inconclusive
    - Latch gang 5-8 and 9-12 were driven simultaneously
      - Latch gang 5-8 reached end of travel at the expected time
- PLBDs cannot be opened with one centerline latch gang closed
- Potentially unsafe to open PLBDs with centerline latch gang at undetermined position
- NEED TO DETERMINE THE LATCH POSITION

- Team was unable to determine latch position with microswitch data
  - Latch may have been fully open with two microswitch failures
  - Latch may have been at a position mid travel
- AC trace data was inconclusive
  - Current magnitude dropped to approximately 50% magnitude when latch gang 5-8 reached end of travel
    - Latch gang slip clutch may have been slipping for entire drive time
    - Latch may have starting slipping half way through drive
    - Latch may have been driving the entire time
